# Commissioning of Exterior Building Envelopes of Large Buildings for Air Leakage and Resultant Moisture Accumulation using Infrared Thermography and Other Diagnostic Tools

Mario D. Gonçalves, Patenaude-Trempe<sup>1</sup>

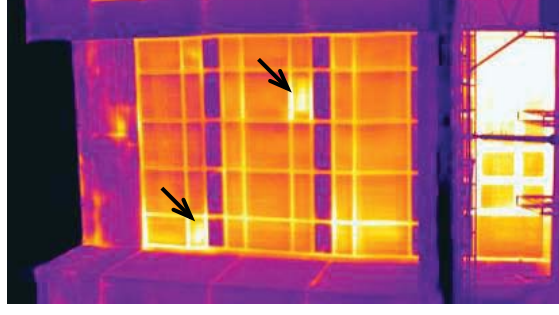
**Figure 1:** What may appear to be a thermal anomaly in the curtain wall assembly is visible in this exterior thermogram (building under positive pressure).

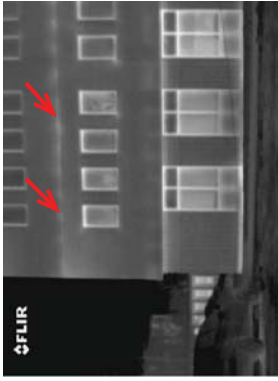
**Figure 4:** Conductive heat loss at masonry structural shelf angle support (building under positive pressure).

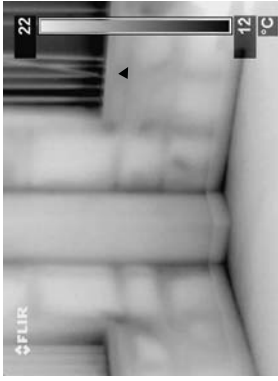
**Figure 5:** Convective heat loss pattern noted below windows (building under negative pressure).

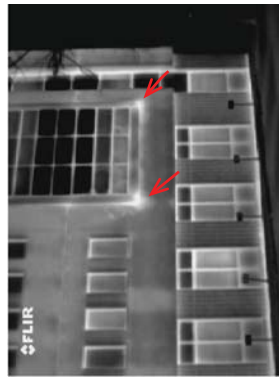
**Figure 6:** Air leakage noted at the bottom corners of the curtain wall assembly (building under positive pressure).

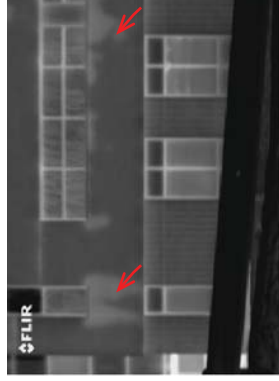
**Figure 7:** Moisture noted below the windows in the exterior masonry wall assembly (building under positive pressure).

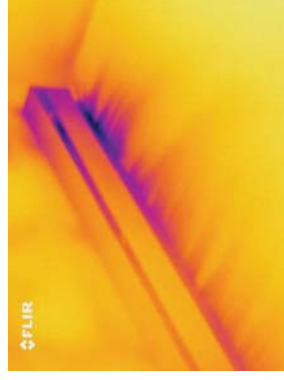
**Figure 8:** Air leakage noted below electric base board (building under negative pressure).

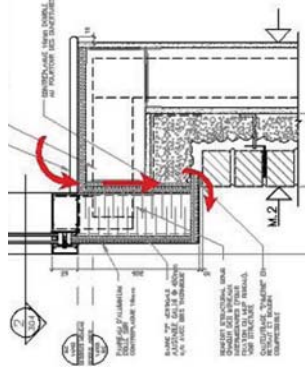
**Figure 12:** Detail drawing illustrating air leakage path.

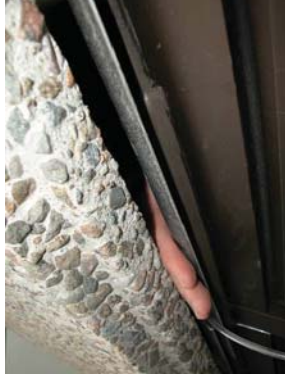
**Figure 13:** Dismantlement of interior finishes at window head reveals direct air leakage path.

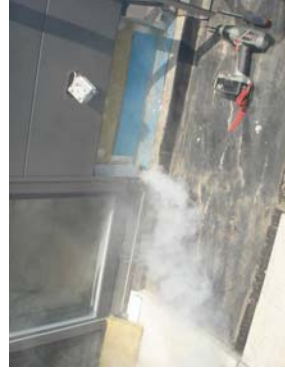
**Figure 14:** Excessive smoke exfiltration below wall assembly.

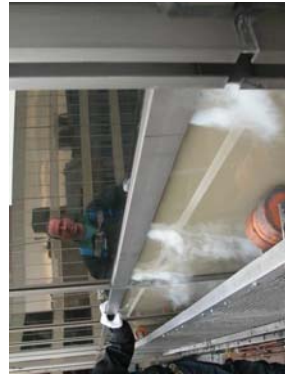
**Figure 15:** Excessive smoke exfiltration at curtain wall weep hole locations.

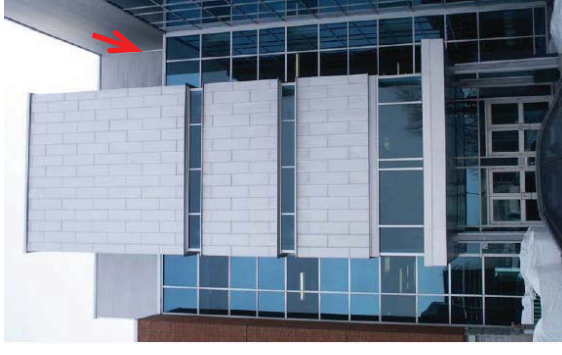
In this example, complaints of flies entering the building at the beginning of the first year heating season were reported by the building owner. A thermographic analysis of the building envelope was undertaken during the heating season. The building was pressurized by means of the building's mechanical systems and excessive air-leakage was noted at the top of several of the curtain wall assemblies (Figures 16 to 20).

Figure 16: Actual photograph of one of the curtain wall sections inspected for air leakage.

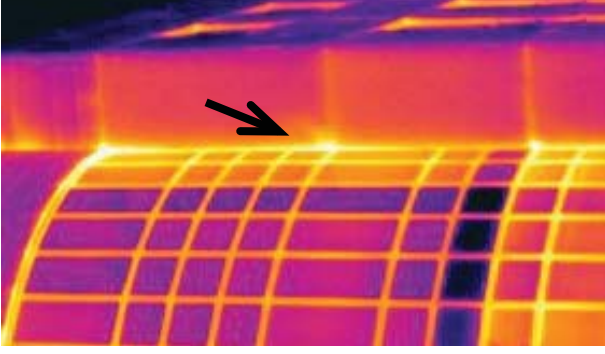
The interface detail between two different wall assemblies is a common source of air leakage and water infiltration problems. In these two examples, a thermographic analysis revealed excessive air leakage at the curtain wall interface with the adjacent masonry, requiring extensive remedial measures to correct.

Figure 27: First example thermogram of interface of curtain wall and masonry wall assembly.

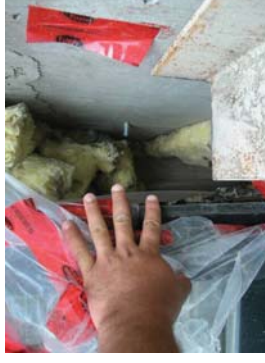
Figure 29: Close-up view of figure 28 - no air seal at the interface detail (the polyethylene sheet was installed as a temporary measure after removing the masonry).

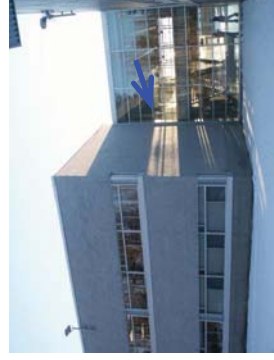
Figure 30: Second example actual photograph of inspected curtain wall and masonry assembly.

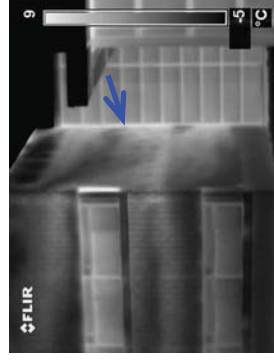
Figure 31: Thermogram reveals excessive air leakage at interface of curtain wall and masonry assembly shown in figure 30. Further investigation confirmed no air seal at the interface detail.
