HOW LEAKY IS YOUR BUILDING? CASE STUDIES OF TWO WHOLE-BUILDING AIR LEAKAGE TESTS

Jason S. Der Ananian, P.E.¹ and Matthew J. Monaghan²

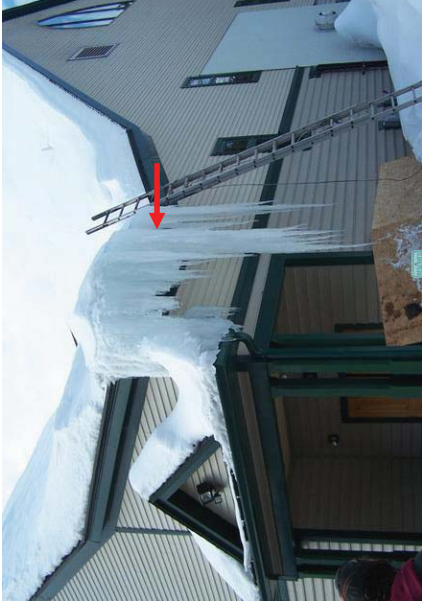
Photo 1: Severe icicle and ice dam formation at metal roof eave (arrow).

Uncontrolled air infiltration through the building enclosure can also allow environmental allergens/pollutants and other airborne particulates to contaminate interior air. In heating climates for all building types, uncontrolled air exfiltration can exacerbate ice formation or ice dams at roof eaves (Photo 1) and increase the risk of condensation in wall assemblies and associated deterioration of cladding assemblies. This risk is greatest in specialty high-humidity buildings such as natatoriums or museums because of the high interior air dew point temperatures.

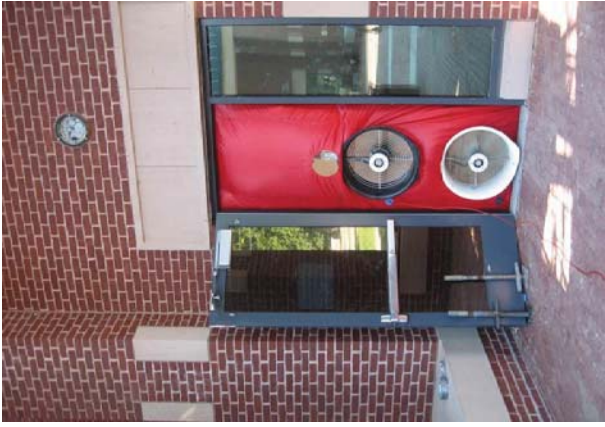
Photo 2: Test setup for blower door test with calibrated fans.

Quantitative Air Infiltration Testing. Blower door testing per ASTM E779 is intended to characterize the airtightness of the building enclosure. The test results can be used to compare the airtightness of the subject building to similar buildings or against criteria set by industry standards or governing building codes. The tests are conducted using calibrated fans (Photo 2) to pressurize and depressurize the building under controlled conditions.

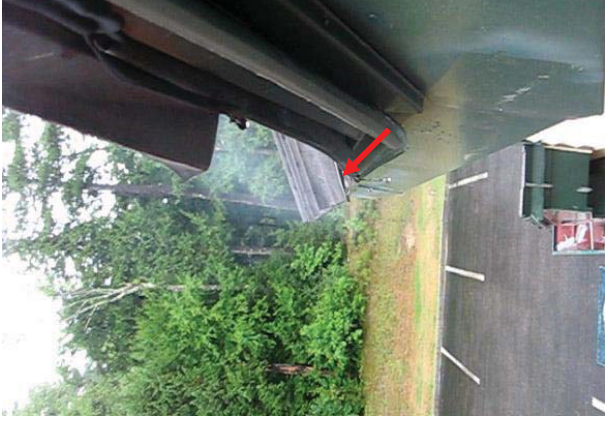
Photo 3: Tracer smoke exfiltration at roof eave (arrow).

Placing the tracer smoke source at the building interior and pressurizing the building or space to locate air exfiltration sites reduces the influence of wind or stack effect. In this case, tracer smoke will be drawn from the building interior through any breaches in the air barrier and be identifiable at the building exterior (Photo 3).

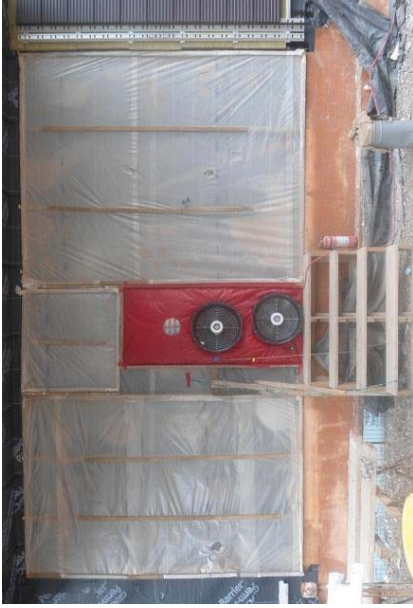
Photo 5: Construction opening with a temporary stud wall wrapped with polyethylene sheet to create an air seal during the test.

The contractor installed a majority of the air barrier and exterior cladding systems prior to the authors' arrival on site. However, several curtain wall openings and HVAC construction openings were incomplete due to fabrication delays. The accelerated construction schedule did not allow postponement of the field test until the contractor installed the remaining HVAC and curtain wall components. Therefore, the construction team in-filled these construction openings with 2x4 stud walls covered with polyethylene sheets (Photo 5) to create a temporary air seal for the test.

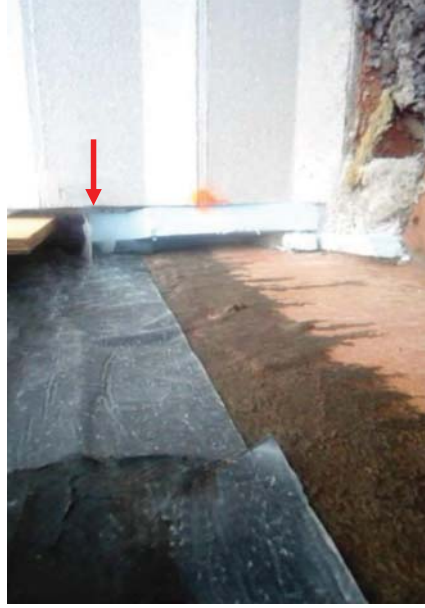
Photo 6: Tracer smoke exfiltration (arrow) at a transition between cladding systems (precast concrete to terra-cotta) and waterproofing membranes (below-grade waterproofing to wall AVB membrane).

Despite the low air leakage rates, smoke testing also identified several air barrier breaches at complex cladding intersections or transition details. Tracer smoke testing identified air leakage at gaps in the above-grade to below-grade waterproofing transition (Photo 6) and the

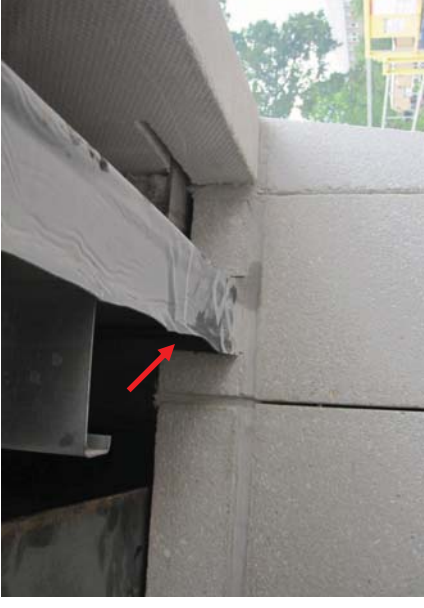
Photo 7: Unsealed beam penetration through air barrier at masonry wall (arrow).

spandrel beam penetration through the air barrier (Photo 7). The contractor immediately repaired these air barrier deficiencies before completing cladding installation.

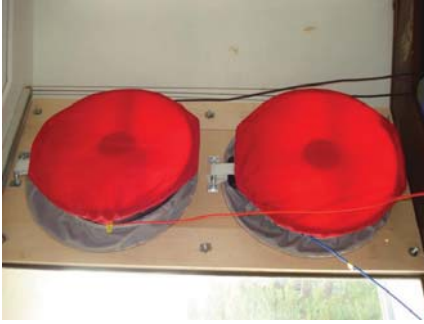
Photo 8: Custom-built blower door frame installed in a window opening.

The high-rise tower required substantial more preparation time for test set-up and execution than the previous case study. This is primarily due to the building height and the need to install blower door frames in existing window openings at intermediate floors to provide a uniform pressure differential on the building enclosure for the full building height. This test required custom-built frames to retain the blower door fans in the existing window openings (Photo 8).

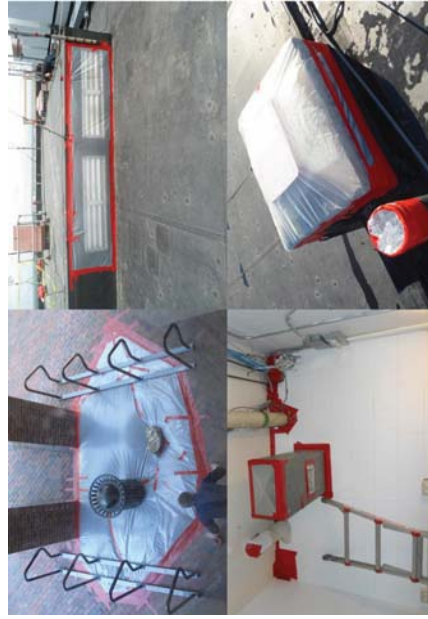
Photo 9: Various envelope penetrations sealed with tape and polyethylene sheet.

Test preparation included propping over 500 interior doors to equalize pressure distribution throughout the building, filling drain p-traps to minimize the risk of sewer gas migration during testing, and air sealing araways at grade, louvers, chimney and other roof penetrations, and hallways connected to adjacent buildings (Photo 9). It took six personnel working in parallel two days to prepare the building for the quantitative testing.

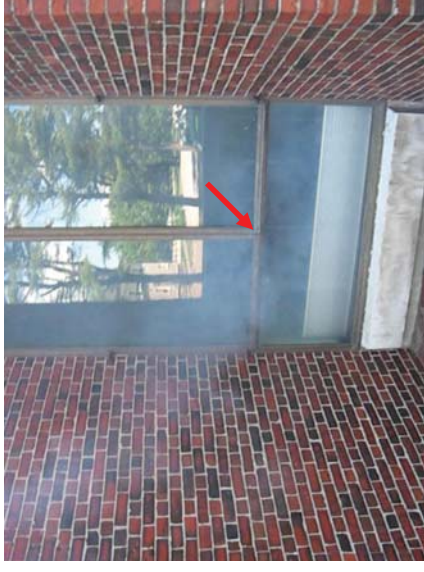
Photo 10: Tracer smoke exfiltration (arrow) at the operable window sash.

industry standards; these results will be used as inputs in a whole-building energy model to better predict building energy use with various enclosure/mechanical system modifications. The tracer smoke testing effectively identified the operable window sash as a major contributor to overall building air leakage (Photo 10).
