Air Tightness Performance of Whole Buildings: Design, Construction and Verification Testing

Wagdy Anis, LEED AP, FALA, Principal

Wiss, Janney, Elstner Associates, Inc.

ASHRAE 1478 RP: Measuring Air-Tightness of Mid and High-Rise Non-Residential Buildings

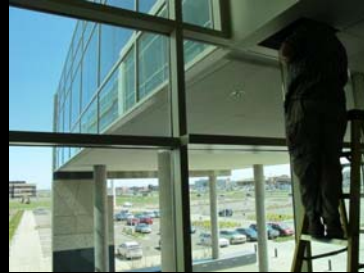
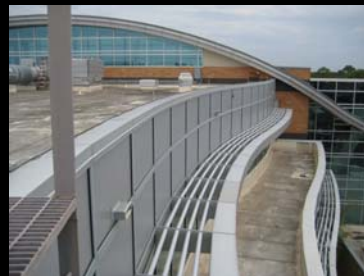
Challenges: Large modern buildings

- Pressure boundary definition
- More penetrations
- Stack and wind effects
- Measuring pressure differences
- Complex geometries
- Uniform air pressure distribution

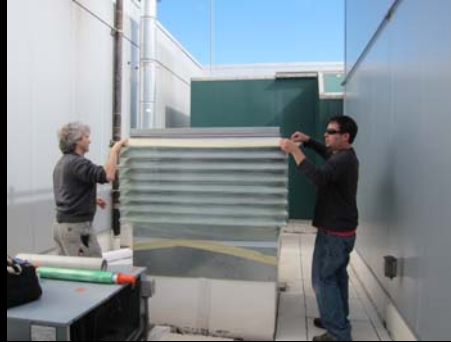
Prepare HVAC System

- Open return air dampers (Create single zone)
- Close operable dampers (OA, exhaust, pressure relief)
- Close or mask gravity dampers
- Mask un-dampened exhausts
- Check for combustion equipment

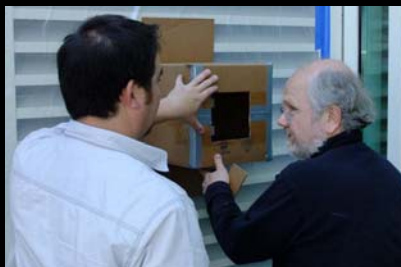
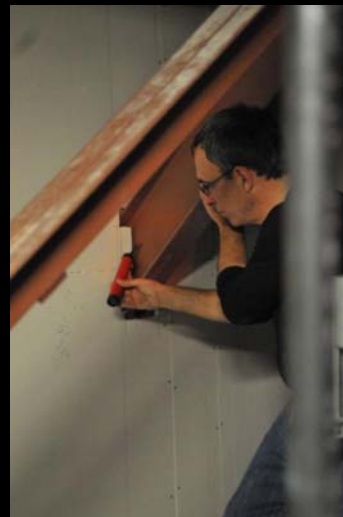
Optional Investigations

- Penetration Masking
- Leakage Site Detection
 - Smoke
 - Infrared

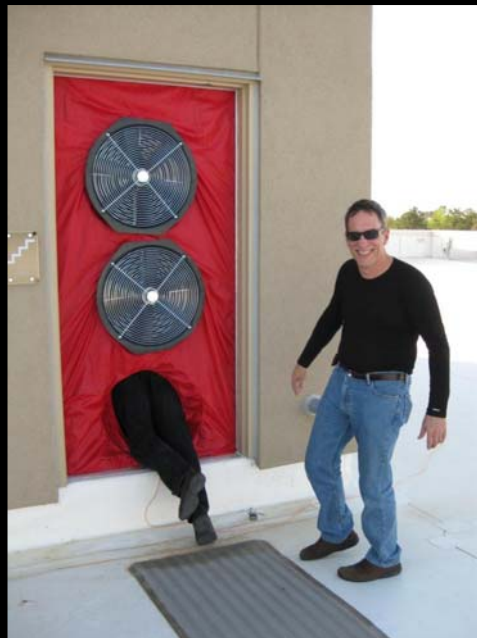
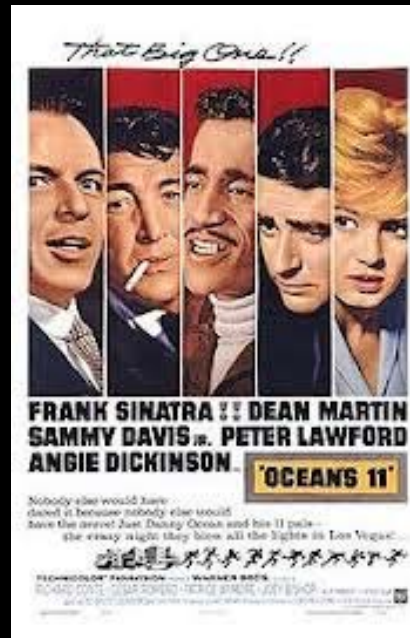
Air Barrier System	<ul style="list-style-type: none"> N None identified Y/N/A Code required Y Part of Design drawings and specifications N Target airtightness level and pressure test specified
Enclosure Description	<p><i>Roofs: Concrete slab with SBS-modified bituminous roofing, a vegetative topping and solar paneling</i></p> <p><i>Walls: Concrete, steel first floor and wood frame construction, 2.5" airspace and 3.6" brick veneer</i></p> <p><i>Penetration: Most windows are operable outward-opening casement style in the living spaces</i></p> <p><i>Foundation: One foot thick concrete wall</i></p>
Architectural features likely to result in significant air leakage	<ul style="list-style-type: none"> N soffits (rear and front) N complex intersections N vented roof assemblies <p><i>Other:</i></p> <ul style="list-style-type: none"> • Loading dock • Open courtyard • Rooftop door weatherstripping • Attic area between finished ceiling and roof • Laundry through-wall equipment

Areas of the building where the air barrier location is uncertain	<ul style="list-style-type: none"> Y mechanical rooms Y attics Y garages (underground) Y crawlspaces Y basements N trenches/tunnels

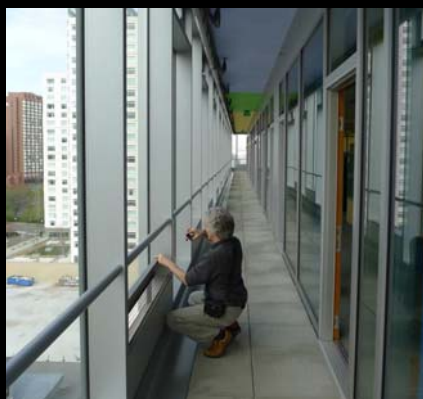
Building 7: Corporate HQ

Results from additional investigation include:

- A 16 Pa pressure difference between the double façade and the building
- Exterior façade was tighter than inner facade

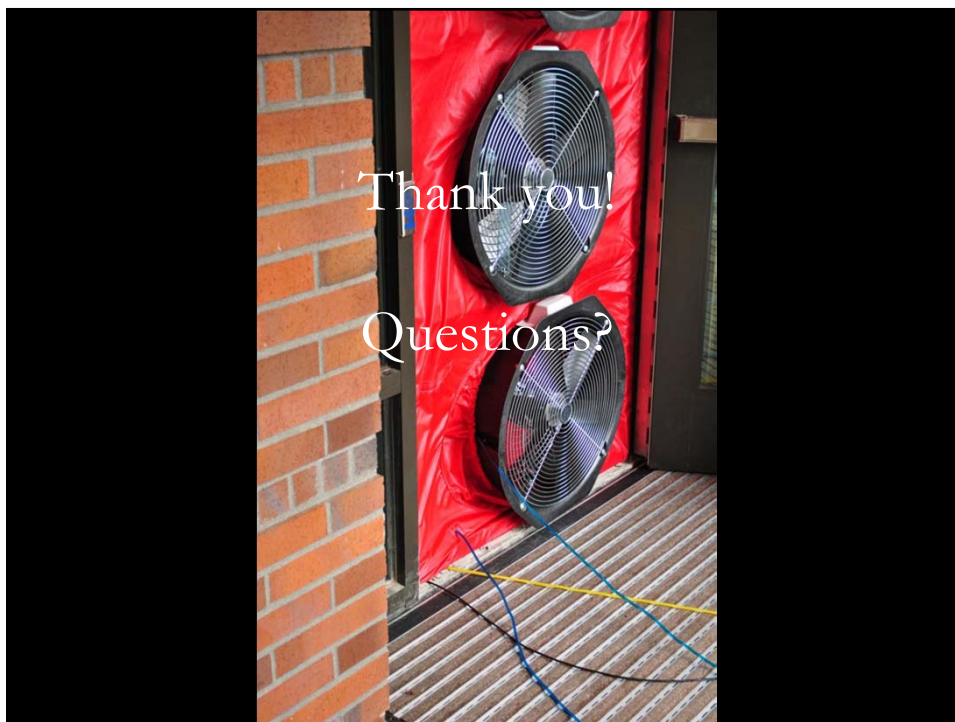
Common Problems

- Areas that should/may be outside pressure boundary
 - Loading docks
 - Mechanical, electrical, generator rooms
 - Garages
 - Double facades
- Roof to wall intersection
 - Separation of building and vented attics
- Fenestration connection to opaque wall / roof
- Soffits, “wings” and canopies connected to building
- Weatherstripping
- HVAC system leakage
 - Stuck dampers, non-adjusted dampers, leaky dampers
 - Damperless exhausts - kitchen hoods, bathroom exhausts
 - Utility tunnel closures in building sometimes non-existent
 - Utility, chimney and pipe wall and roof penetrations unsealed.
