# Commissioning of Exterior Building Envelopes of Large Buildings for Air Leakage and Resultant Moisture Accumulation using Infrared Thermography and Other Diagnostic Tools

Mario D. Gonçalves, Patenaude-Trempe<sup>1</sup>

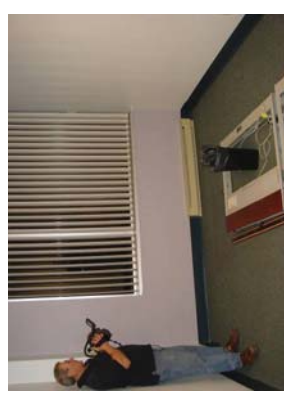
**Figure 8:** Air leakage noted below electric base board (building under negative pressure).

**Figure 9:** Actual photograph of corresponding area.
